FIRE SAFETY STUDY

SMITHFIELD BATTERY ENERGY STORAGE SYSTEM

SMITHFIELD BESS

DOCUMENT NO: 21895-RP-001

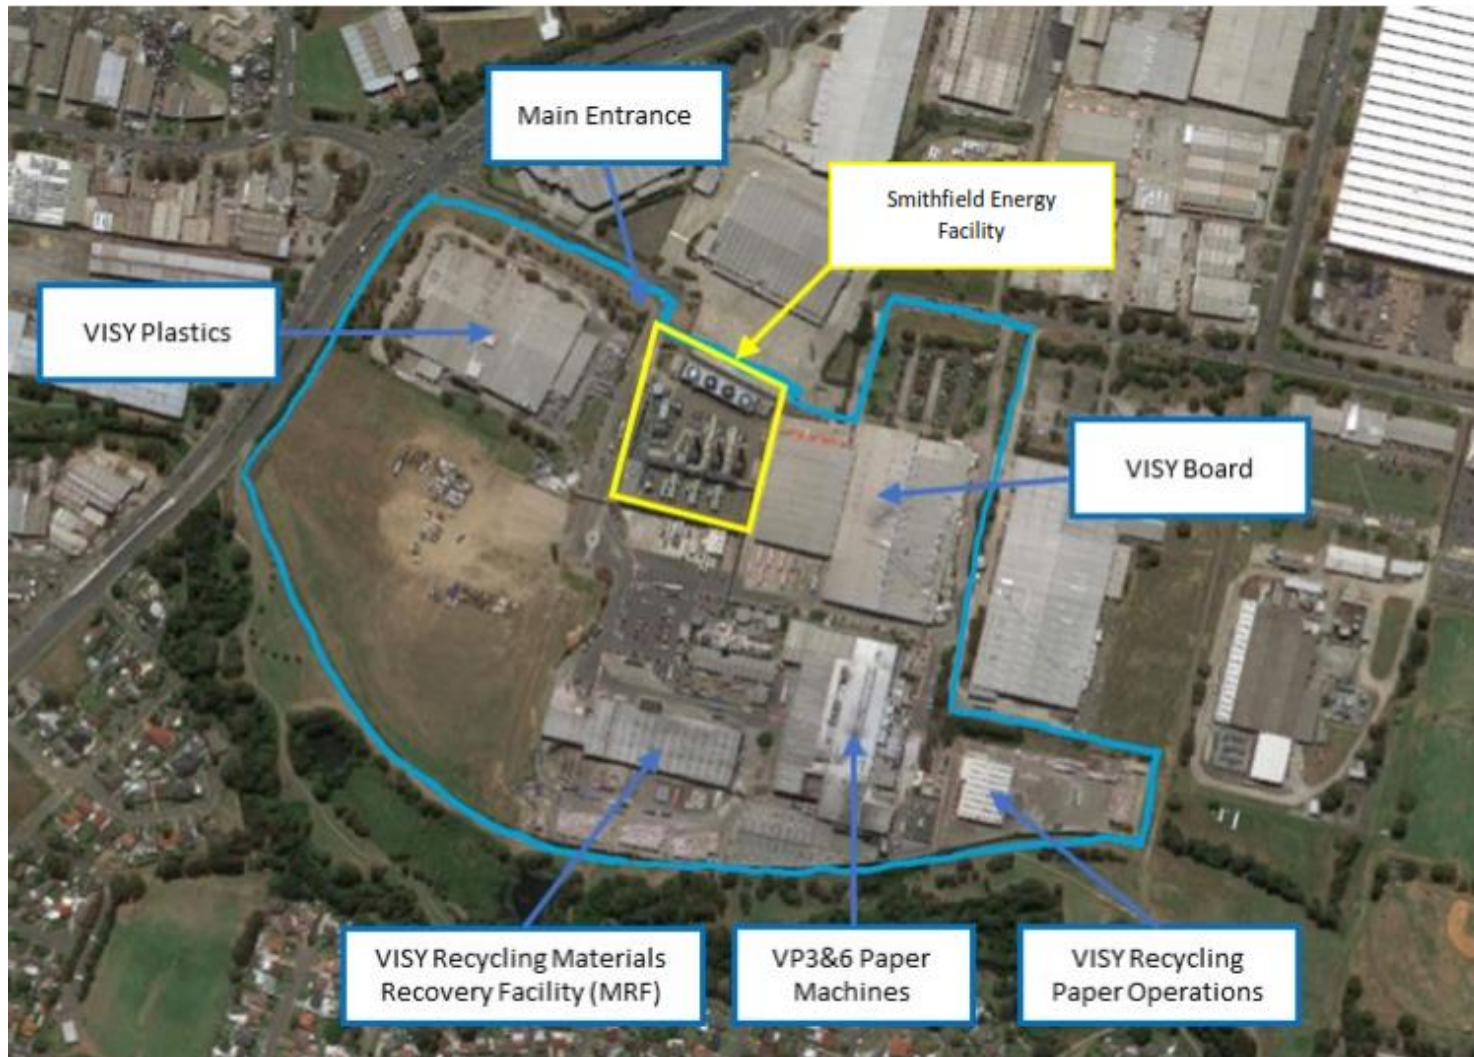
Figure 3.1: Site location and local surrounds

The Smithfield facility is located at 6 Herbert Place, Smithfield NSW 2164 (Lot 33, DP850596). The BESS units will be installed in the north of the site, where the SEF cooling towers are currently located. The cooling towers will be removed as part a separate project. The site layout is provided in Figure 3.1.

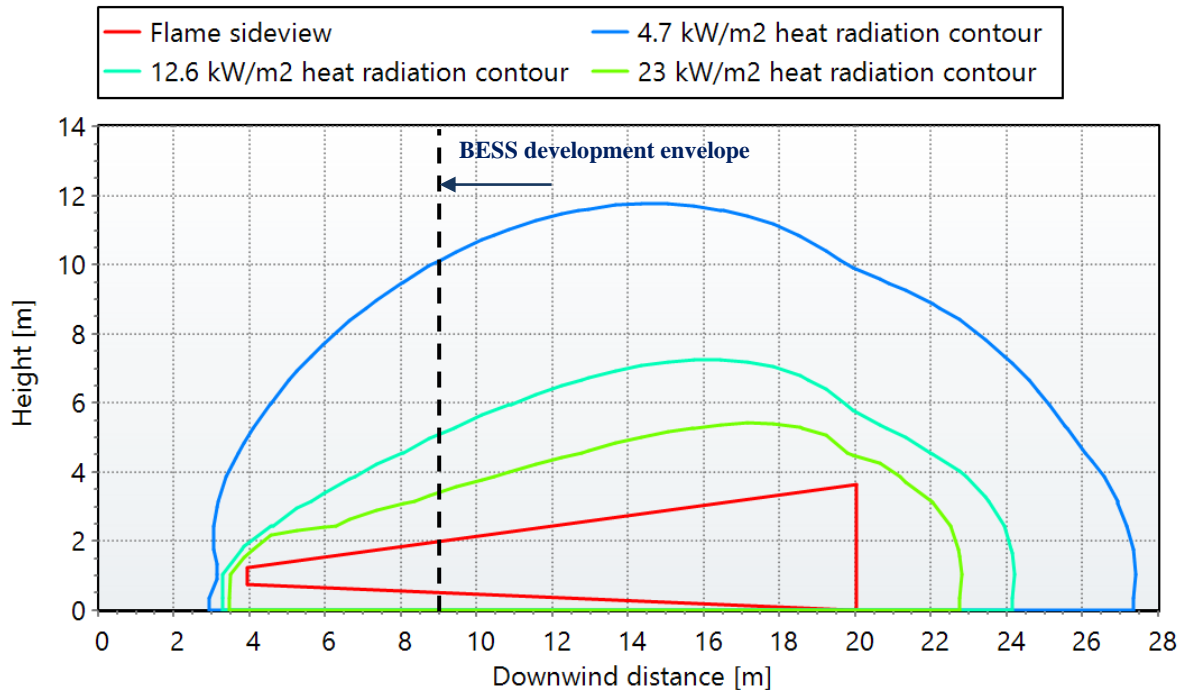
Figure C.2: Heat radiation sideview (20 mm leak- D2)

Material	Leak Size (mm)	Release Pressure (bar)/ Temperature (degC)	Wind Weather Stability	Distance (m) at Receiver Height (1 m) to Radiation Levels		
				4.7 kW/m ² (injury)	12.6 kW/m ² (fatality)	23 kW/m ² (structural failure)
Natural gas (Methane)	10	38 barg 25 degC	B3	14	12	11
			D2	14	13	12
			D5	13	11	11
			F1	15	14	13
Natural gas (Methane)	20	38 barg 25 degC	B3	26	23	21
			D2	27	24	23
			D5	25	21	20
			F1	29	26	25
Natural gas (Methane)	50	38 barg 25 degC	B3	60	52	49
			D2	63	56	52
			D5	57	49	46
			F1	67	60	56
